OCSCC 976 – PARKING GARAGE ASSESSMENT REPORT
300 Lett Street, Ottawa, Ontario

FILE # 1250638
2025-10-20

OCSCC 976 – PARKING GARAGE ASSESSMENT REPORT 300 LETT STREET, OTTAWA, ONTARIO

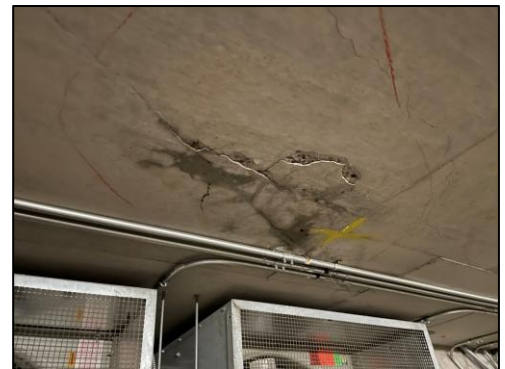
- 6.1 Soffit concrete delaminations were generally present at locations where leaks were occurring or where efflorescence was present.

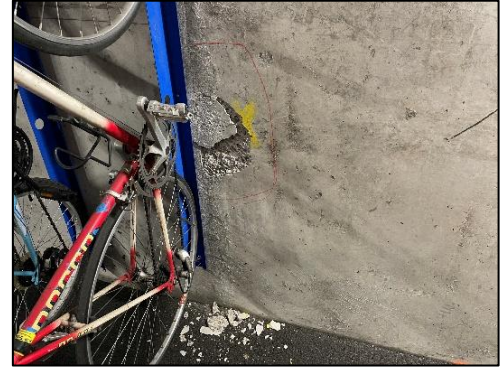
- 6.2 Wall concrete delaminations were observed at a vertically mounted bicycle rack. A leak was noted to be directly above this area.

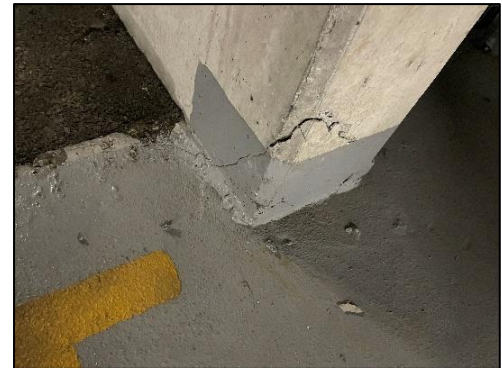
- 6.3 Localized concrete delaminations were evident at localized shear walls and columns throughout the garage.

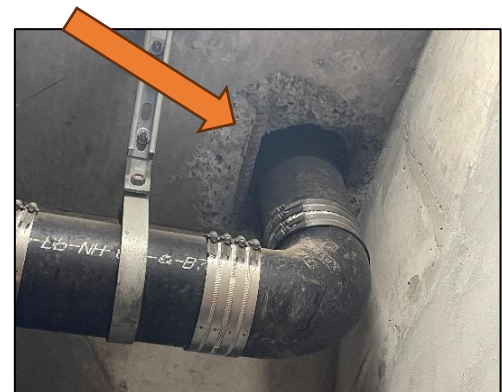
- 6.4 Steel reinforcing was exposed at localized drain locations.

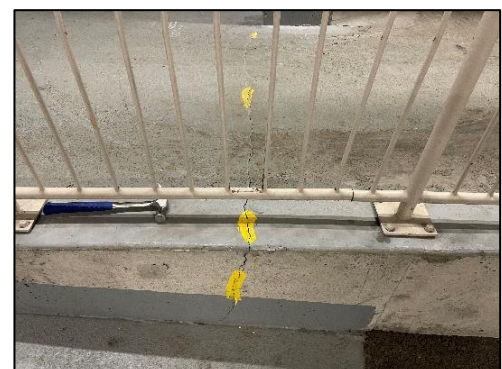
- 6.5 Surface cracks were observed at various locations throughout the garage with varying widths.

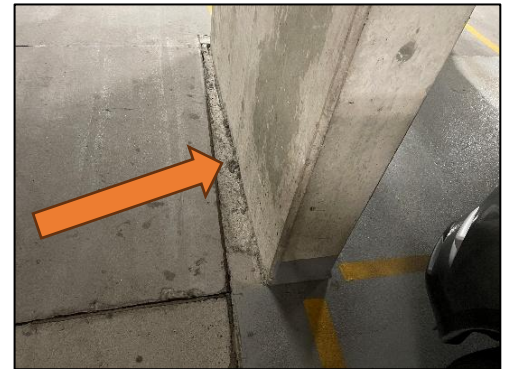
- 6.6 A section of concrete next to the ramp access was exposed and the abutting shear wall was also missing a waterproofing upturn.

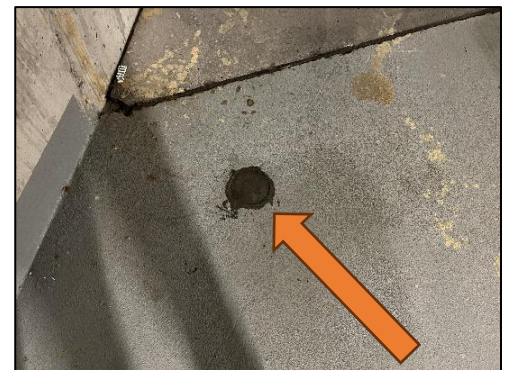
- 6.7 An abandoned concrete core location through the suspended slab was noted to be filled. However, no waterproofing membrane had been applied over the area.

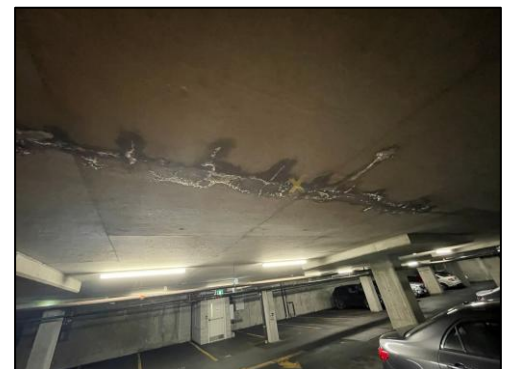
- 6.8 At most soffit delamination locations, efflorescence is present. This is consistent for walls, columns, and soffits.

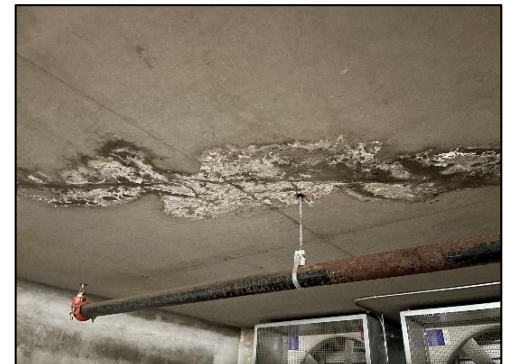
- 6.9 Soffit delamination and mineral deposits were noted above a fire suppression sprinkler. A section of the fire suppression pipe directly below the leak is beginning to corrode.

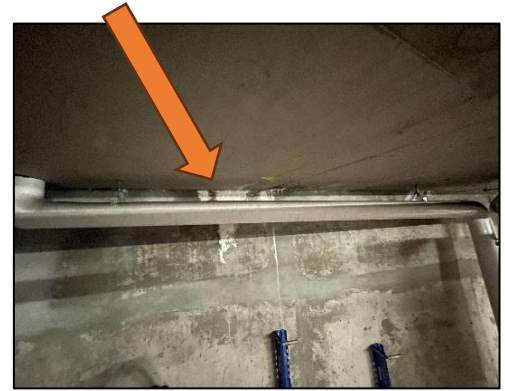
- 6.10 Efflorescence staining was evident on the soffit of the suspended slab below the area where water pools on the level above.

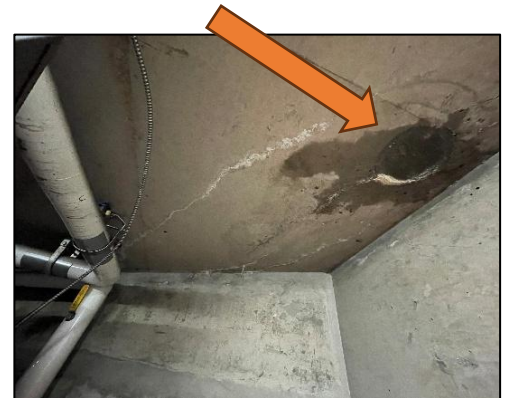
- 6.11 An abandoned concrete core location through the suspended slab was noted to be filled. The underside of the repair was noted to be significantly wet and was presenting efflorescence staining at the surrounding surfaces.

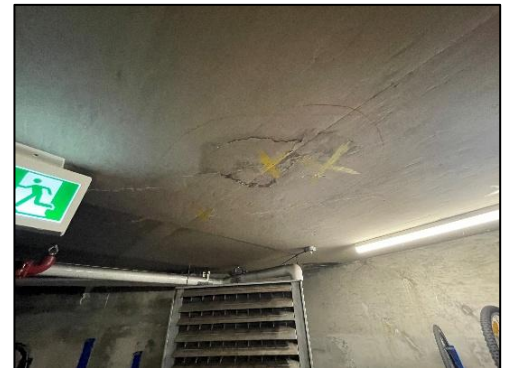
- 6.12 A concrete soffit delamination was found along a cold joint of the suspended slab.

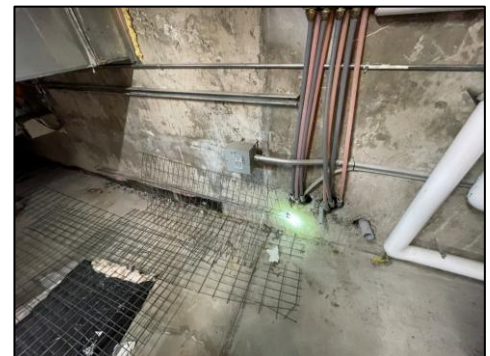
- 6.13 Many localized wall leaks were noted throughout the parking garage utility rooms.

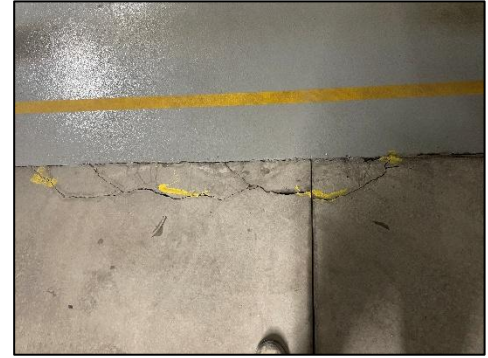
- 6.14 Localized concrete slab surface cracks were evident at an intersection between the membrane and non-membraned concrete.

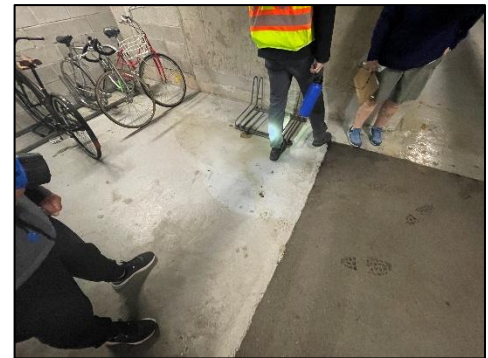
- 6.15 Water pooling was noted near the bike racks on level P2. The concrete may be sloped toward this area. No reglet or termination bar was present at the joint between the membrane and the non membraned concrete.

At OCSCC 976, the through slab drains were in fair condition with moderate to significant surface corrosion. During concrete repair projects, it is recommended these through slab drains are removed and new drains with the proper membrane tie-in flange are installed. Areas of water ponding were also noted in the garage. At least three (3) new drains should be installed throughout the garage to allow water to drain at the areas of water pooling.

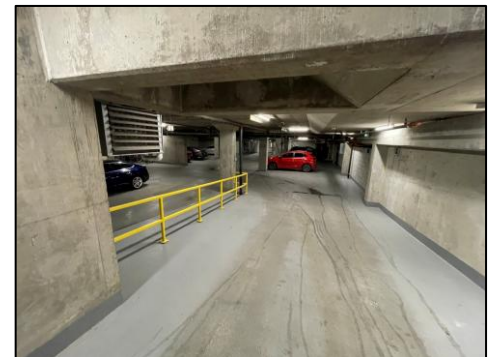
- 6.16 Water pooling was observed at the base of the P1 garage entrance ramp.

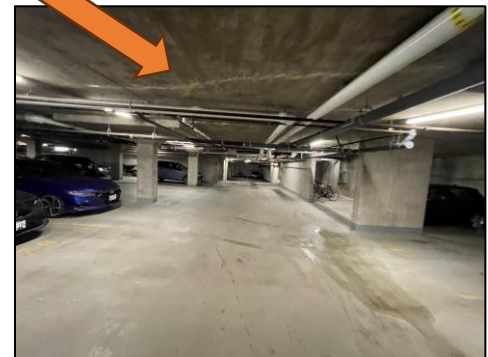
- 6.17 Efflorescence staining was noted at areas of cracking on the soffit of the podium level.

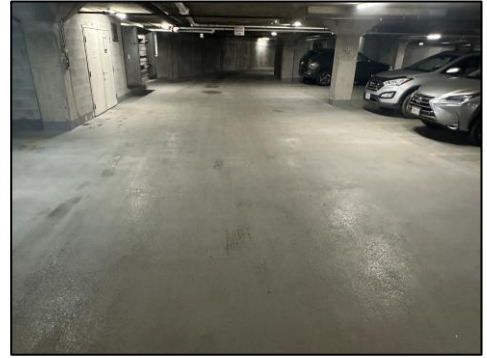
- 6.18 The membrane on the level P1 and P2 was significantly worn down at areas of high traffic, i.e. turn radii, driveways and ramps.

At OCSCC 976, the debonding of the membrane is very apparent in localized areas, especially in areas where significant efflorescence staining was noted on the soffit below. Select high-traffic areas were also noted to have widespread physical damage and wear to the waterproofing membrane. Although the concrete delaminations at/below these areas is limited, it is recommended that repairs be completed in these areas to prevent excess water and chloride infiltration into the slab, leading to structural damages and the associated additional costs with concrete repair work. Although there have been some areas of premature wear in the drive lanes and parking spaces where the traffic membrane has debonded, the overall condition of the traffic membrane is on par for the age of the building (10 years).

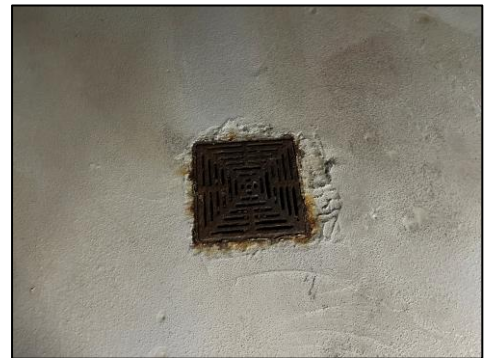
- 6.19 Overview of typical condition of cast iron through slab drain. Through slab drains are significantly corroded.

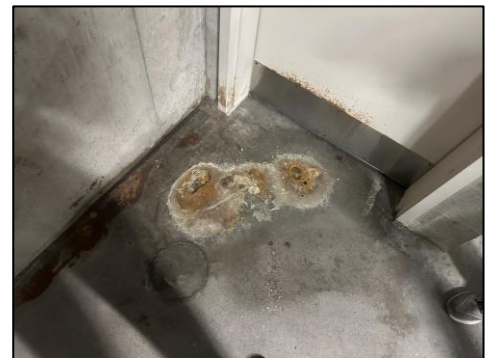
- 6.20 Efflorescence and corrosion staining along with concrete pitting was noted on the slab on grade concrete surface on P2 at an entrance door to one of the building blocks.
